COLLAPSE OF STRUCTURAL STEEL FRAMING DURING CONSTRUCTION

Forensic Engineering in Construction® is published by Zallen Engineering, 1101 Worcester Road, Framingham, MA 01701. Comments are welcome. Please direct comments to Rubin M. Zallen, P.E., by telephone at 508-875-1360 or by e-mail at rmzallen@zallenengineering.com.

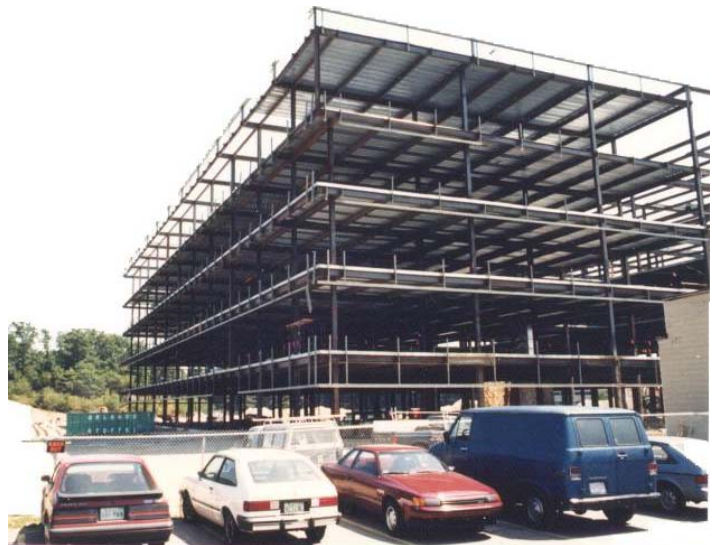
Figure 1. View of the northwest corner of the building, showing the area where the steel framing collapsed during erection.

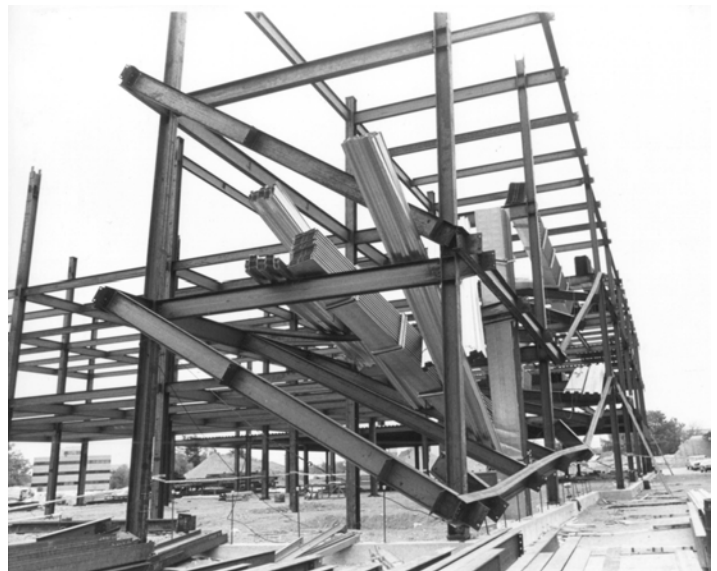
Figure 2. View of collapse at northwest corner of the building, taken prior to the removal of debris.

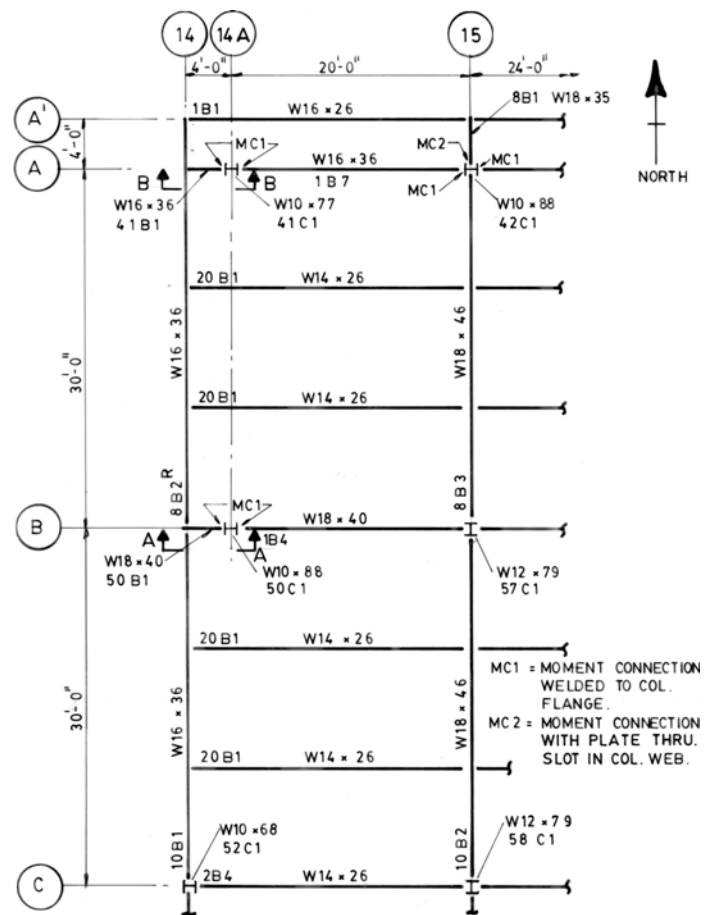
Figure 3 is a schematic plan showing the floor framing in the area of the collapse. The figure shows beam and column sizes and the steel fabricators identification numbers for framing referred to in this narrative. The symbols *MC1* and *MC2* denote moment connections between beams and columns; all other connections are simple connections. Figure 4 is a section showing the cantilever framing along the west side of the building.

The contract drawings and the approved shop drawings indicated that the flanges and webs of cantilever beams 41B1 and 50B1 (see Figure 3) were to be welded to the flanges of columns 41C1 and 50C1, respectively, in the fabricating shop, with full penetration welds (i.e. welds through the full thickness of the steel of the web and flanges of the beam). However, the fabricator revised the detail before fabrication to that shown on Figure 4, so that an erection angle would be welded to the column flange in the shop, the cantilever beam would be shipped separately, the cantilever beam web would be temporarily bolted to the erection angle in the field, and the cantilever beam flanges

Figure 3. Schematic framing plan of 2nd, 3rd, and 4th floors, in the area of the collapse.

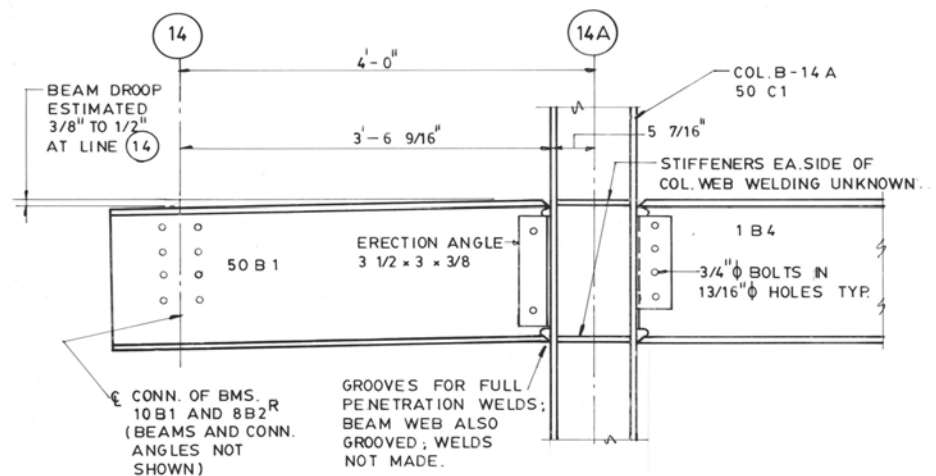
Figure 4. Section A-A, showing cantilever framing along the west side of the building at the time of the collapse.

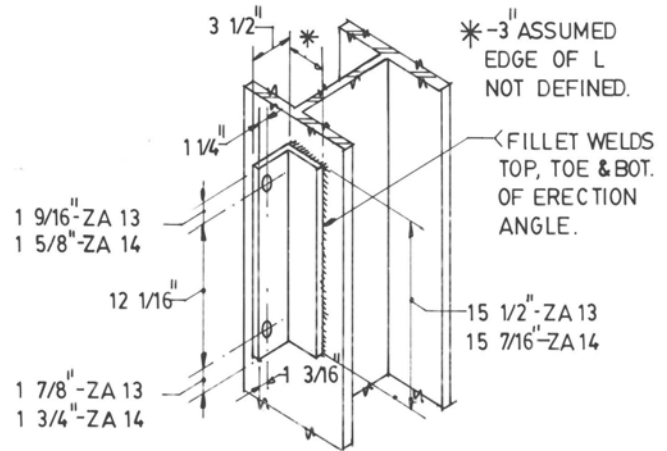
and web would thereafter be connected to the column flange by the required full penetration welds. Figure 5 shows the details of the erection angles at Column 50C1

The permanent, full penetration, welded connections of the ends of the cantilevers to the faces of the flanges of Columns 41C1 and 50C1, which were designed to resist moment, were not made. Therefore, the moment and shear due to the weight of the deck bundles and steel framing had to be resisted by the erection angles and the welds connecting them to the faces of the column flanges.

Figure 5. Detail of the erection angles at Column 50C1.

Thus, the collapse was most probably initiated by the failure of the weld between Column 50C1 and the erection angle attached thereto at the third floor, due to the moment applied to it by the load on the cantilever; the failure propagated to the weld between Column 41C1 and the erection angle attached thereto at the third floor; the third floor collapsed on to the second floor; the similar welded connections at Columns 50C1 and 41C1 at the second floor failed; and the second floor then collapsed.

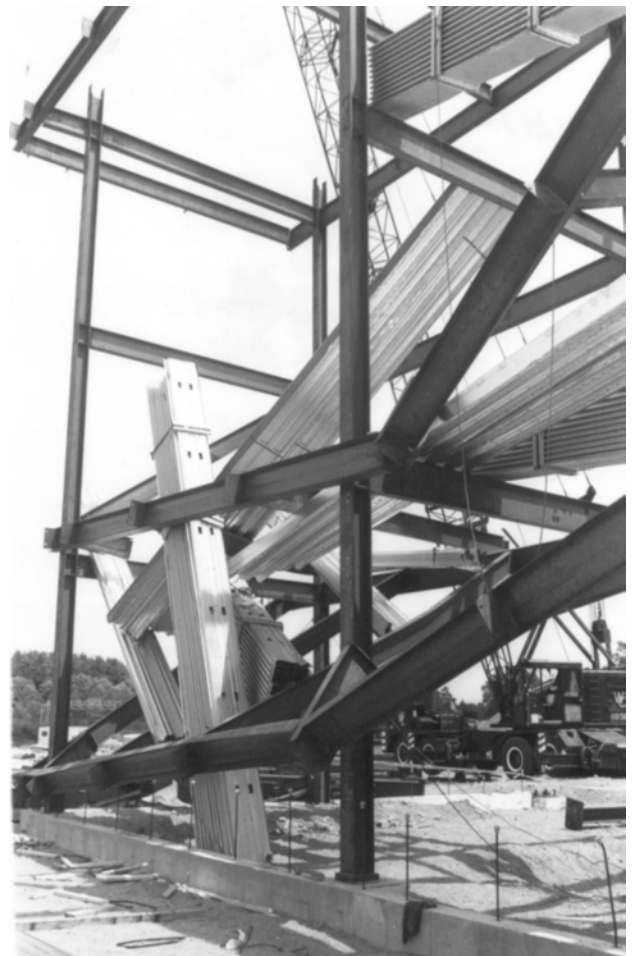
Figure 6. View of collapse looking northeast.

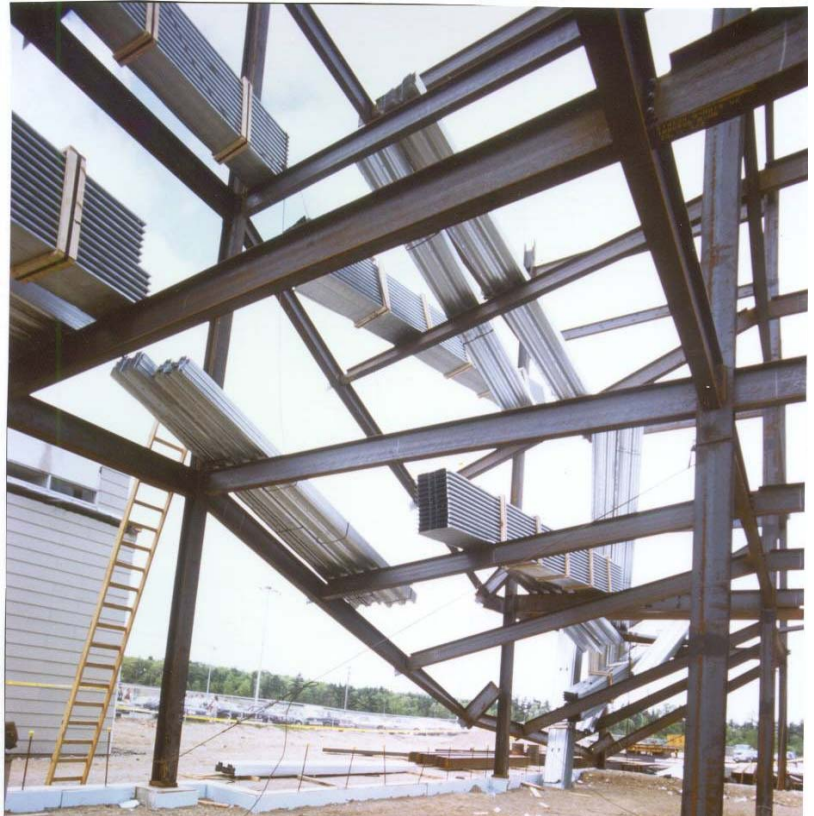
Figure 7. View of collapse looking northwest.
