DEFICIENCIES IN BRACING OF LIFT SLAB BUILDINGS

Forensic Engineering in Construction® is published by Zallen Engineering, 1101 Worcester Road, Framingham, MA 01701. Comments are welcome. Please direct comments to Rubin M. Zallen, P.E., by telephone at 508-875-1360 or by e-mail at rmzallen@zallenengineering.com.

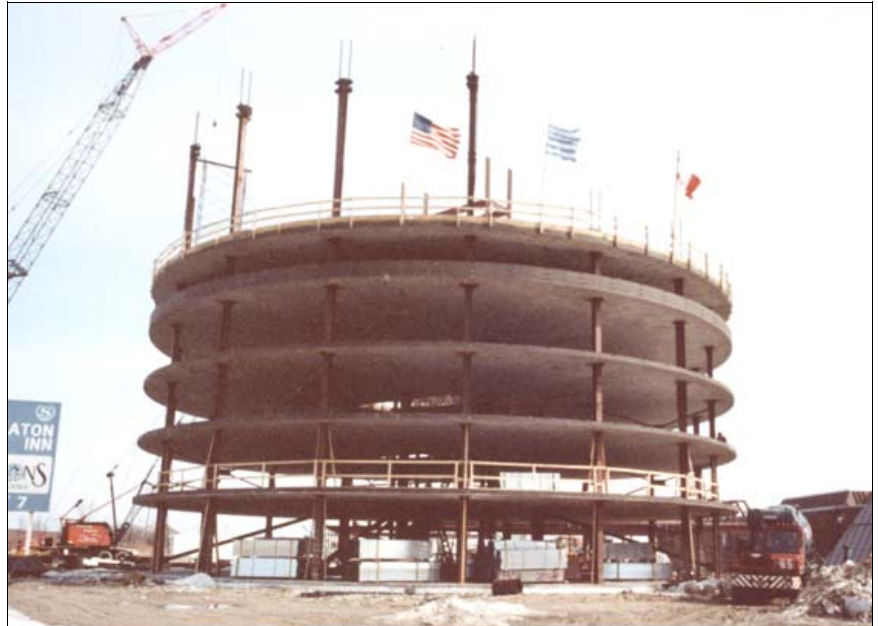
Figure 1 Lift slab construction of hotel tower in Portland, ME. Lifting is completed for the first tier of columns; second tier of columns with jacks on top are partially erected; slabs at top are temporarily parked.

Figure 1 shows a circular hotel guest room tower when it was under construction, in Portland, Maine. Zallen Engineering was retained to make a structural investigation when concrete tests showed that the strength of the concrete in one of the post-tensioned floor slabs was materially deficient. The investigation revealed that the lateral load resisting system for the structure had substantial deficiencies.

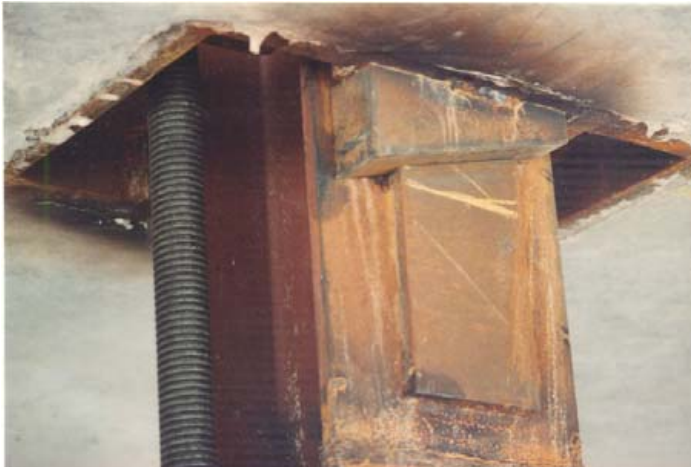
Figure 2 Detail at bottom of steel lifting collar. Slab temporarily parked. One of two lifting rods is shown on left; other rod is hidden on other side of column. Left and right sides of lifting collar extend beyond opening at bottom of slab, but extensions are hidden by cement paste.

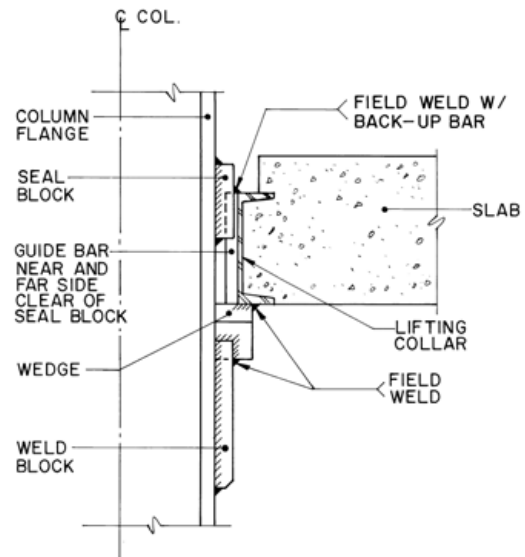
Figure 3 Section through lifting collar and column flange showing connections of lifting collar to the column flange. Seal block was omitted at multi-story condominium buildings.

Referring to Figure 3, the seal blocks were omitted on this project, and at some locations which were designated to have special moment connections, the observed width of spaces between the column flanges and the lifting collars varied between $1\frac{1}{2}$ and $1\frac{7}{8}$ inches. At some of these locations, round bars were placed between the guide bars and column flanges, and were welded to each; at other locations, large round bars or two smaller bars welded to each other were used between the lifting collar and column flanges, and were welded to each; and in one observed case, $1/8$ inch diagonal plates covered the gap between the guide bars and the column flanges and were welded to each.

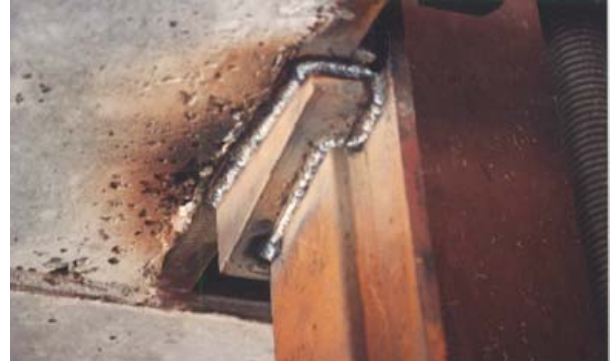
Figure 4 Wedges welded to weld block, column, and lifting collar.

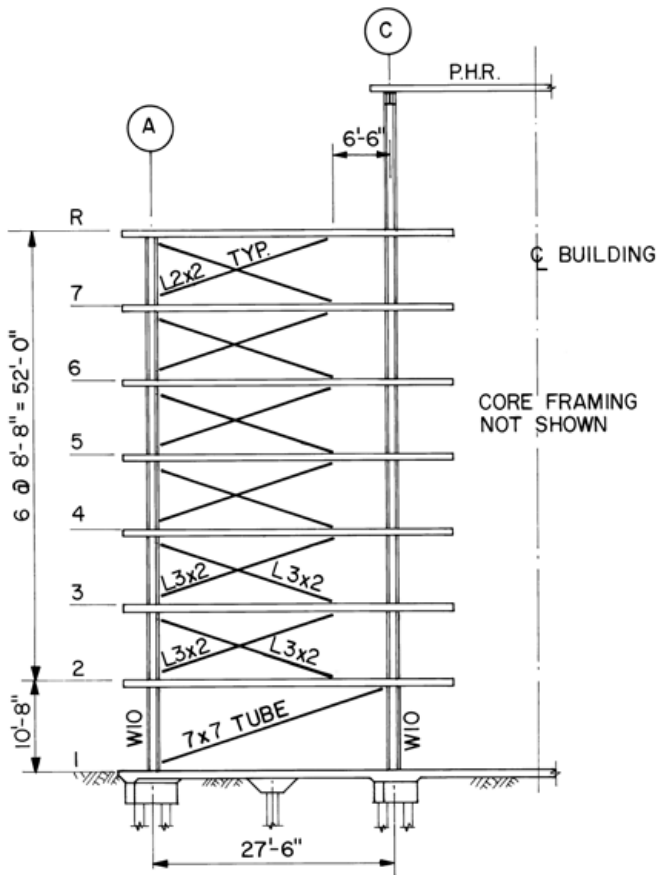
A second deficiency was that one end of the diagonal cross-bracing members did not terminate at a column, but terminated within the span of the slabs. See Figures 6 and 7. Under lateral load, the forces from the bracing would impose large vertical concentrated loads on the slabs which in turn would impose large bending effects (moments) on the slabs, which the slabs were not designed to resist.

Figure 6 Schematic radial cross-section of hotel tower at a typical braced frame. Framing for core of building is not shown.

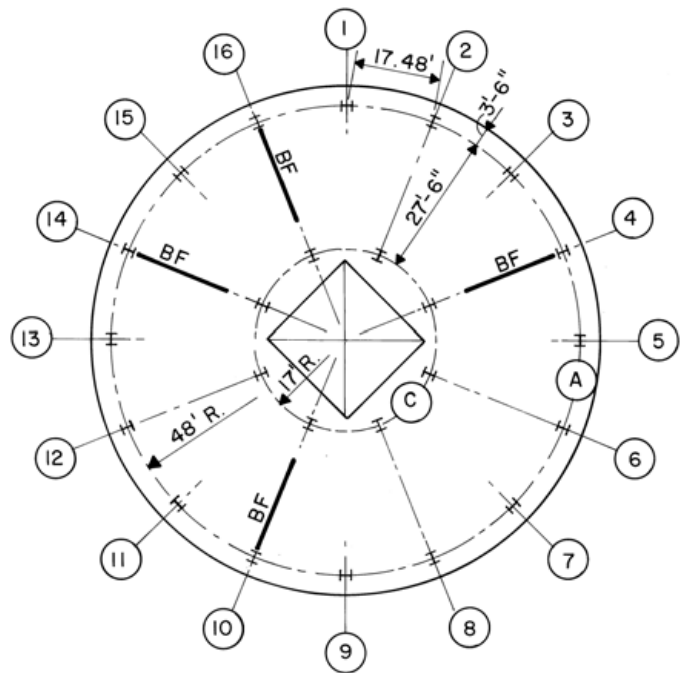
frame. The first deficiency was that the planes of all the brace frames were radial and intersected at a single vertical axis (at the center of the circle). There was no other *significant* lateral load resistance; thus the structure was torsionally unstable -- i.e. the whole structure could rotate about a vertical axis located at the center of the circle.

Figure 5 Schematic plan of typical floor of hotel tower. The mark BF denotes a radial braced frame. Framing for core of building is not shown.

Zallen Engineering recommended that chevron type steel braced frames be constructed at strategic locations on the outer circumferential column line to provide the necessary lateral resistance for the building. However the architect and his structural engineer opted to create rigid frames in the circumferential direction, by reinforcing the connections between the slabs and the columns to obtain the required bending moment resistance.

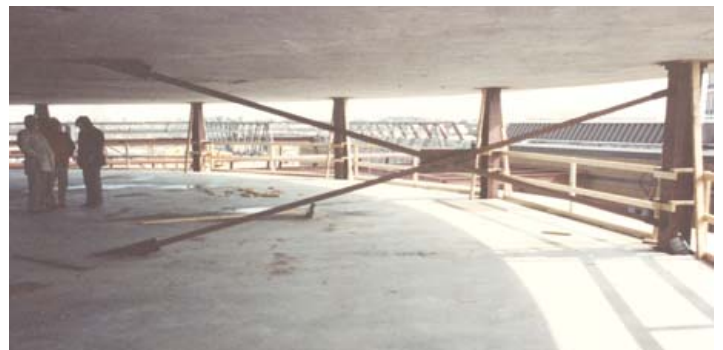
A third deficiency was that the diagonal bracing was designed for strength but not stiffness, and a low 10 psf wind load, which resulted in very small sizes for the diagonal bracing. The resulting system is very flexible and substantially under strength; under a wind load, the (vertical) gravity loads acting on the structure in its *laterally deflected* position would amplify the effects of the wind load on the bracing by 36% (the P-) effect).

Figure 7 Typical radial braced frame.

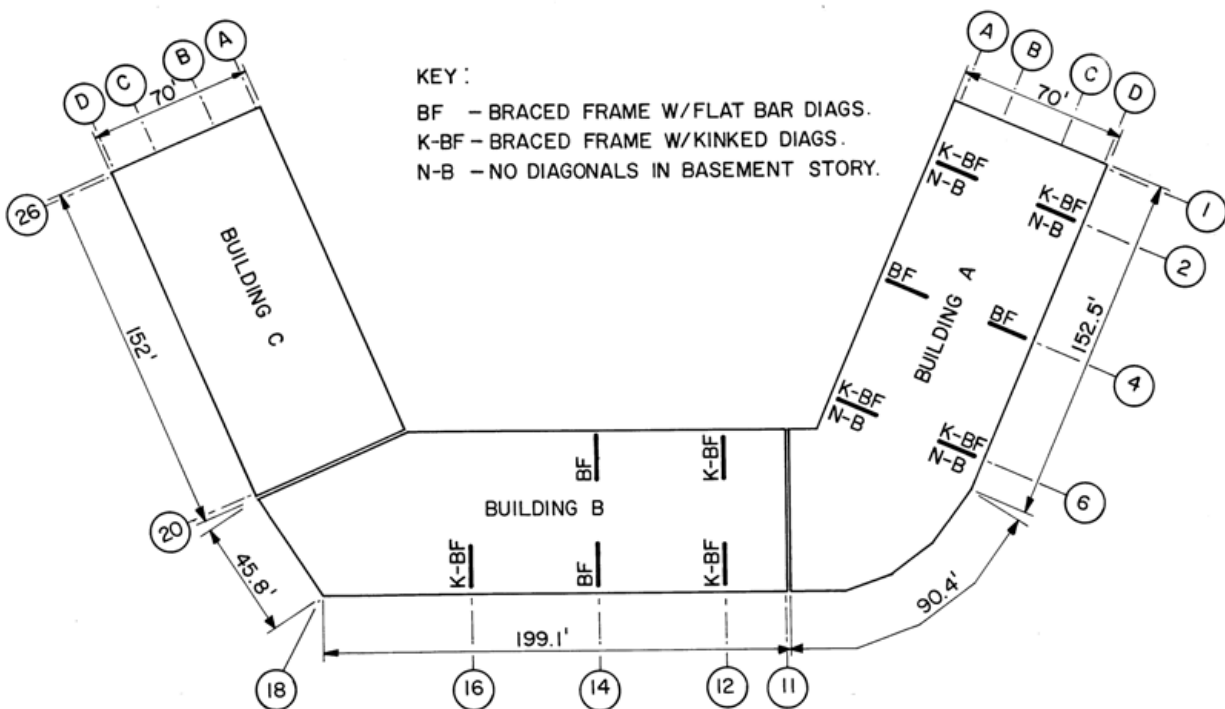
Figure 9 Schematic plan of typical floor of condominium complex, showing locations of braced frames.

The lateral load resisting system consisted of braced frames from the basement to the bottom of the 4th floor, as located on Figure 9, and moment resisting (rigid) frames composed of floor slabs and columns where special connections of the lifting collars were made to *some* of the steel columns.

The braced frames had diagonals that could transmit tension only: straight flat bars, as shown on Figure 11, or a kinked configuration as shown on Figure 12. The location of each type is given on Figure 9. Referring to Figure 10, for wind in one direction, only the diagonals on one side of the building are effective, and for wind in the other direction, only the diagonals on the other side of the building are effective. As indicated on Figure 9, some of the diagonals were omitted from the basement story garage, and in one case, on Line 16, there was a braced frame on only one side of the building, which meant that the bracing on that line could resist lateral load in one direction only. Also, as indicated on Figure 9, there were no braced frames at all in Building C.

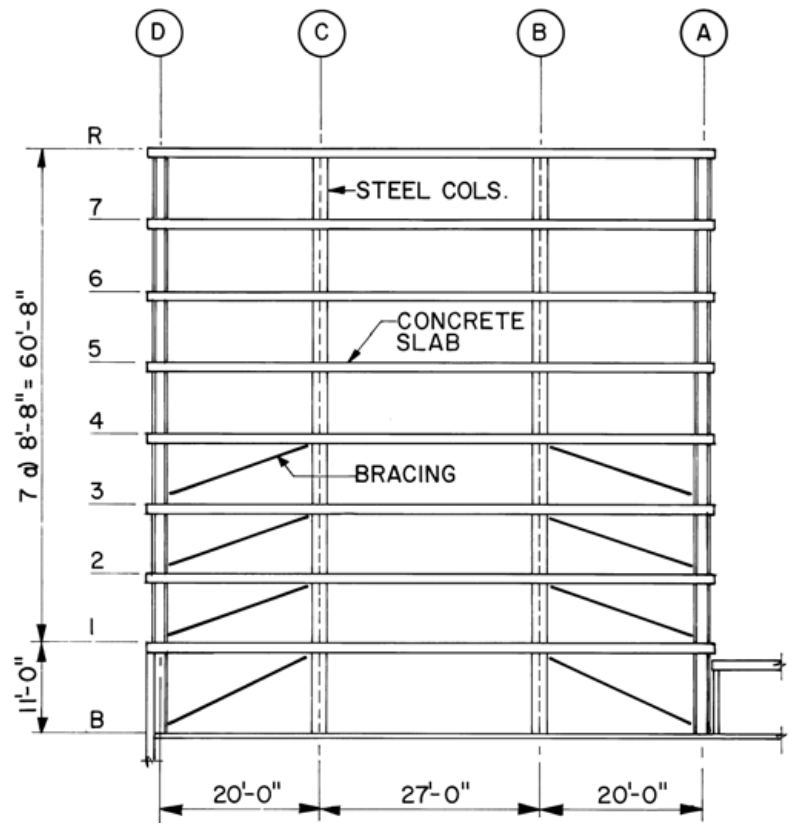
Figure 10 Schematic cross-section of condominium buildings showing braced frames with flat bar tension diagonals. At some locations the diagonals were "kinked" - see Figure 12. At some locations in Building A, basement story diagonals were omitted.

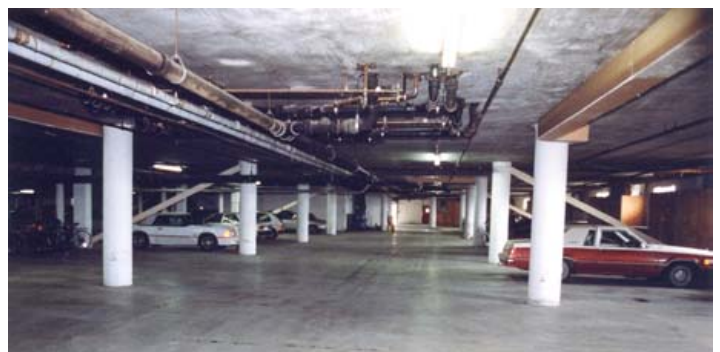
Figure 11 Typical flat bar diagonals of braced frames in condominium buildings; diagonals shown are in basement story of Building B. Columns are steel, but are encased in concrete in the basement garage.

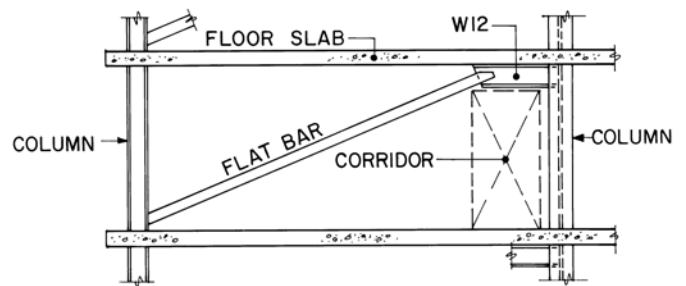
The lateral load resisting system was significantly overloaded when subjected to the code specified wind load. The kinked diagonals in the braced frames were essentially ineffective in resisting force and the moment connections between the slabs and the columns had little moment resistance and were generally inadequate. Further, some of the flat bar diagonals of the braced frames were severely overloaded, with ratios of load to safe load as high as 1.7, the nominal safety factor for steel.

Figure 12 Typical kinked tension diagonal of braced frames.
