## Collapse of a Trunk Storm Sewer in Boston

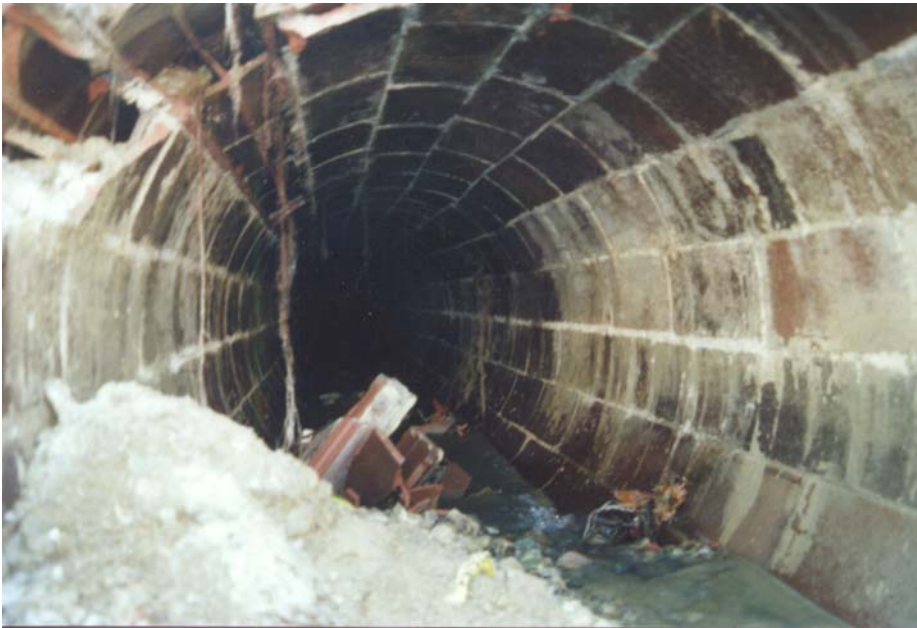
**Figure 1.** Trunk storm sewer west of the collapse, showing structural clay tile construction. The sewer is 5'-6" in diameter and there are 18 tiles around the circumference

As part of the license agreement for building over the sewer, the City required that the developer have a video made of the condition of the sewer prior to construction. The required video was made by a robot specially designed for the purpose, and the making of the video was witnessed by the developer. At that time, the developer discovered that the sewer was of clay tile construction, not concrete; however, he did not inform the City or anyone else of the changed condition. Figure 1 is a photo of the inside of the sewer showing the clay tile construction.

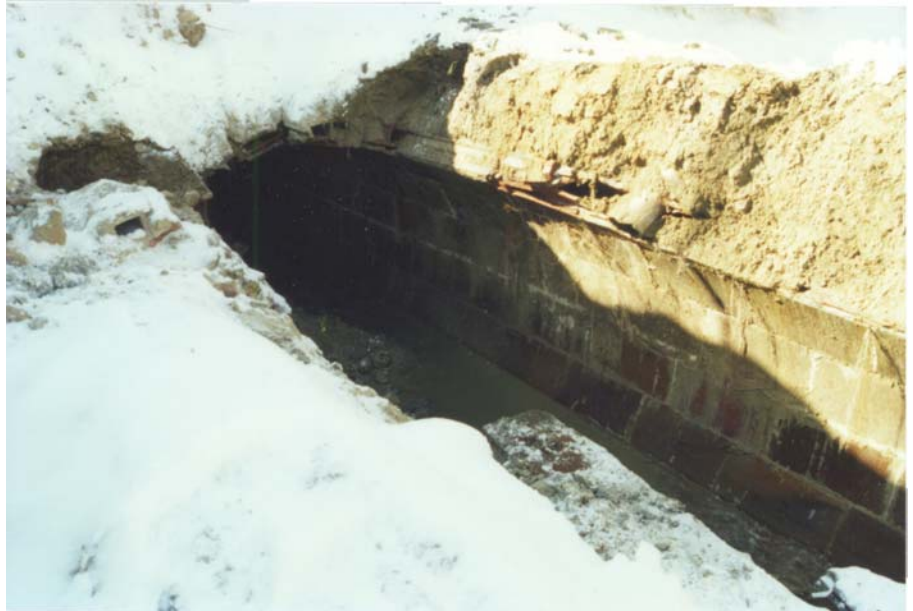
**Figure 3. Collapsed storm sewer at the west end of the collapse, looking northwest.**

The sewer collapsed just after the excavation subcontractor completed his work and parked his machine beyond the southeast corner of the excavation. Figure 2 shows the extent of the collapse, Figure 3 shows a portion of the collapsed sewer, and Figure 4 shows details of its clay tile masonry construction. The depth of the soil over the top of the sewer, just before the collapse, was approximately 3 feet where the grade beam trenches crossed over the sewer, and 8 feet between the grade beam trenches.

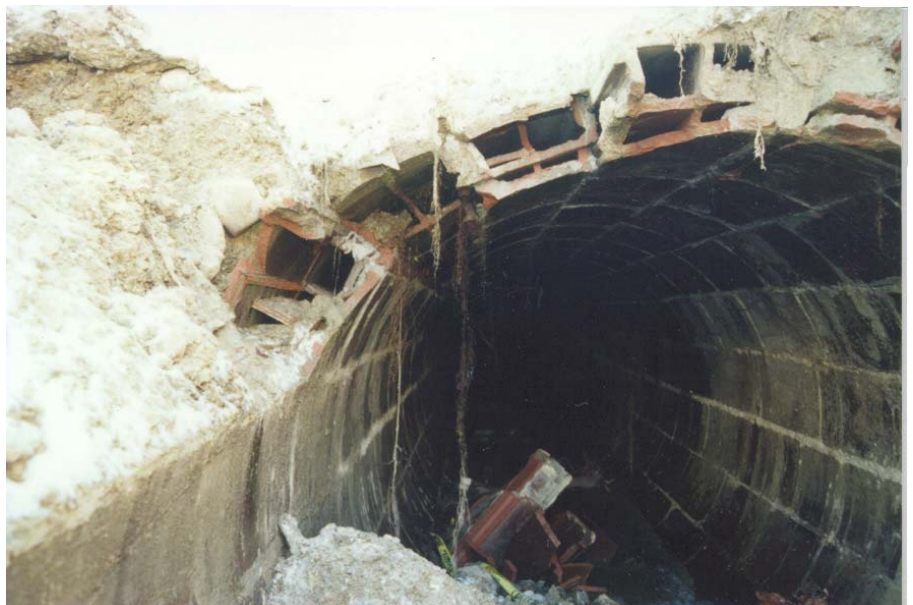
**Figure 4. West end of collapsed storm sewer, showing details of the clay tile construction.**

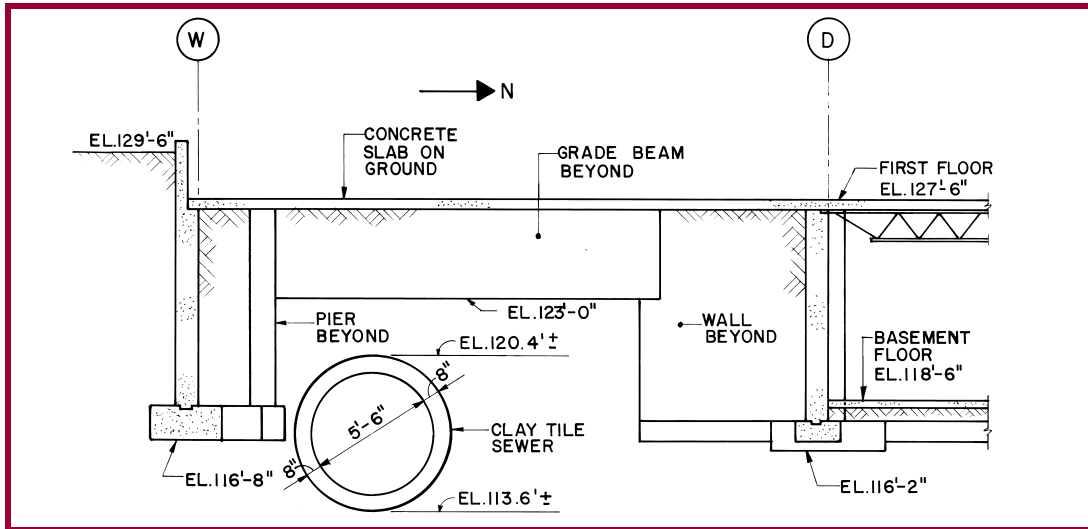
for the short extension wall on Line 21, and for the grade beam from grid point Y-21 to grid point X-22. The excavation subcontractor then excavated a trench for the foundation wall on Line W, which is south of the sewer, moving from grid points W-6 to W-22, and finally excavated for the short wall on Line 22. The depth of the trench for the wall on Line W was just below mid-height of the sewer (see Figure 5).

**Figure 5. Section A-A, through the foundation and storm sewer. See Figure 2 for location.**

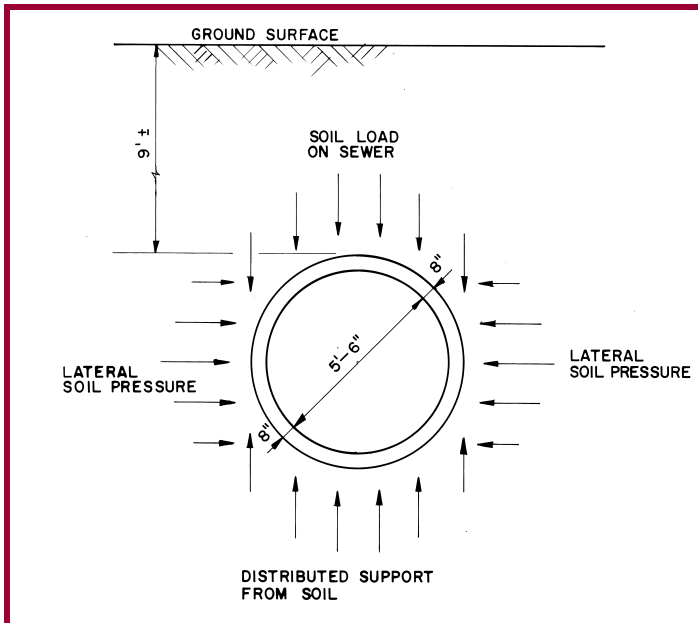
The clay tile masonry sewer was constructed in-place, with the use of formwork and shoring. The sewer has a circular ring shape, which can be envisioned as two arches, one arch on top of a second inverted arch. See Figures 1 and 6. The lateral soil pressure on each side of the sewer provides the lateral thrust on each side that is necessary for the stability of the “two arches.”<sup>1</sup> When the soil was excavated on one side (the south side) of the sewer for a length of approximately 34 feet, a substantial portion of the lateral soil pressure against the side of the sewer ring was removed. See Figure 7. This loss of lateral pressure resulted in a substantial loss of lateral thrust and an asymmetrical loading condition, which caused the collapse of the sewer.

**Figure 6. Section through the storm sewer, showing conditions prior to excavation and soil pressures on the sewer.**

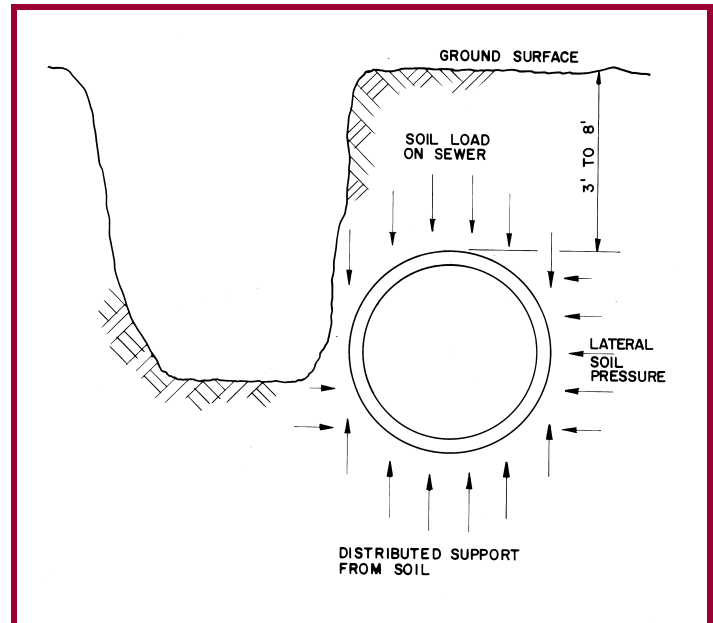
**Figure 7. Section through the storm sewer showing conditions just prior to the collapse. Lateral soil pressures on the sewer were substantially reduced by the excavation on one side of the sewer.**
