Collapse of Roof Over Chemical Settling Pond

Forensic Engineering in Construction® is published by Zallen Engineering, 1101 Worcester Road, Framingham, MA 01701. Comments are welcome. Please direct comments to Rubin M. Zallen, P.E., by telephone at 508-875-1360 or by e-mail at rmzallen@zallenengineering.com.

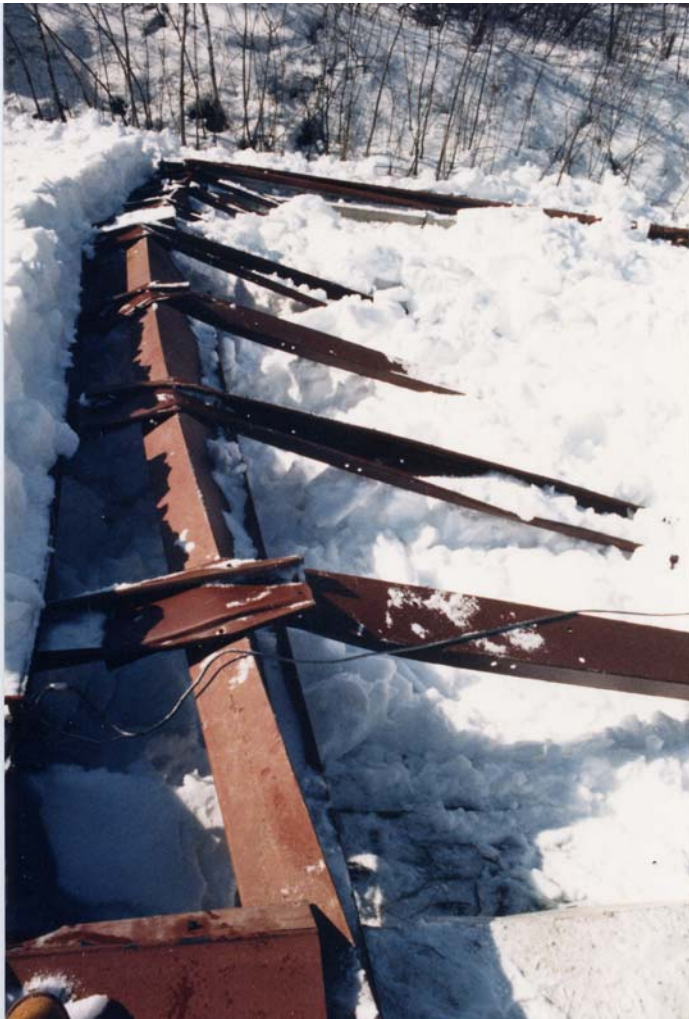
Figure 1. View of collapse of roof over chemical settling pond, showing a typical condition of the framing. All the light gage steel purlins across the entire width of the roof have rolled over away from the viewer.

The roof collapsed due to lateral-torsional buckling of the roof purlins, as shown in Figure 1. The roof panels and the tops of the purlins on both sides of the roof moved laterally as a unit in one direction (in Figure 1, away from the viewer). Although the tops of the purlins were ostensibly laterally braced by being attached to the roof panels, there was an insufficient mechanism to prevent the roof panels from moving in their own planes transverse to the purlins.

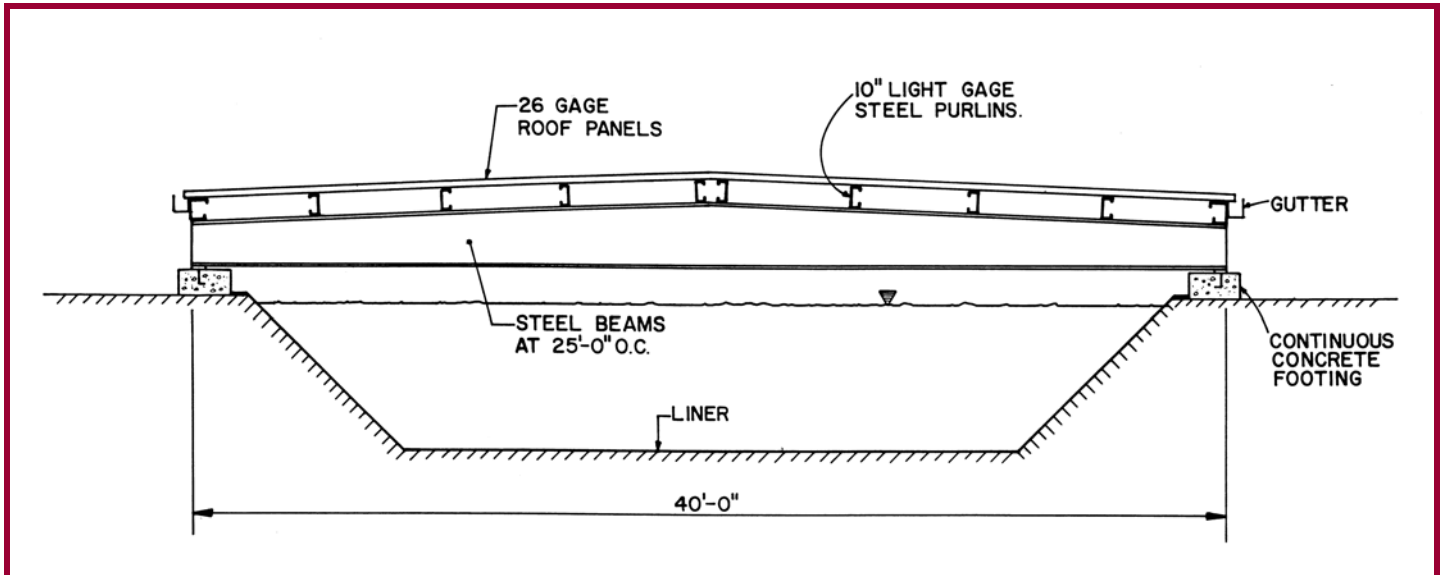
In 1985, a chemical manufacturer in Eastern Massachusetts built an artificial pond to settle out solids from a chemical liquid. The pond was excavated into the ground, the ground surface within the pond was covered with a Hyperlon liner, and the pond was covered by a roof of metal building construction. The roof was 250 feet long and 40 feet wide. Figure 2 shows a cross-section through the pond and the roof.

Figure 2. Cross-section through roof and settling pond.

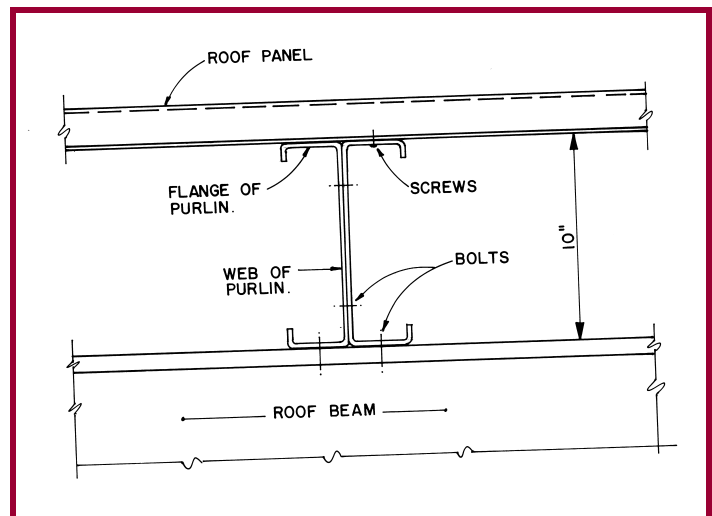
The roof framing consisted of 10 inch deep light gage steel "C" purlins on top of tapered steel roof beams. The beams were spaced at 25 feet on center. The purlins were lapped and bolted back-to-back over their supports, and the bottom flanges of the purlins were bolted to the top flanges of the supporting beams, as shown on Figure 3. The beams were supported at each end by bearing plates on continuous concrete footings.

Figure 3. Typical detail of the roof purlins at their supports.

Referring to Figure 3, if the roof panels and the top flanges of the purlins try to move laterally, the only resistance to this movement is transverse bending of a small length of the webs of the purlins close to the supporting beams. These small lengths of the webs of the purlins can be envisioned as a group of cantilever columns with a 10 inch height, fixed against rotation at the bottom. If these "columns" are too flexible as a group, they will buckle as a group, with the tops of the "columns" moving laterally. This is the mechanism that allowed the purlins to roll over as a group and caused the roof to collapse. Generally, the webs of light gage steel purlins or the webs of structural steel purlins will

not be sufficiently thick to prevent this mode of failure. Had the purlins been properly laterally braced, they would not have failed and could have resisted the full code ultimate load.

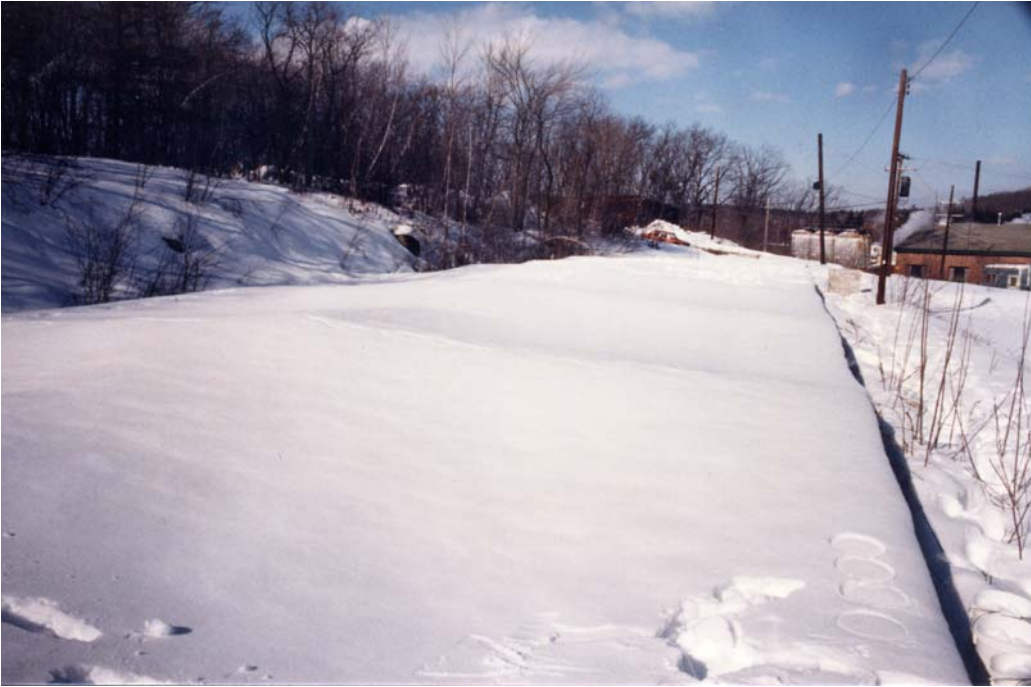
In February of 1987, there was a heavy snowstorm in the area, but without heavy winds. As a result a relatively uniform layer of snow of an average depth of 20 inches was deposited on the roof. The entire roof collapsed, but the collapse was arrested by a thick layer of ice that had formed at the top of the pond. Figure 4 shows the collapse before the snow was removed. Figure 1 shows part of the collapse after some of the snow was removed. The collapse was not discovered

Figure 4. View of the collapsed roof, the day after the collapse. The collapse was arrested by a thick layer of ice at the top of the pond.

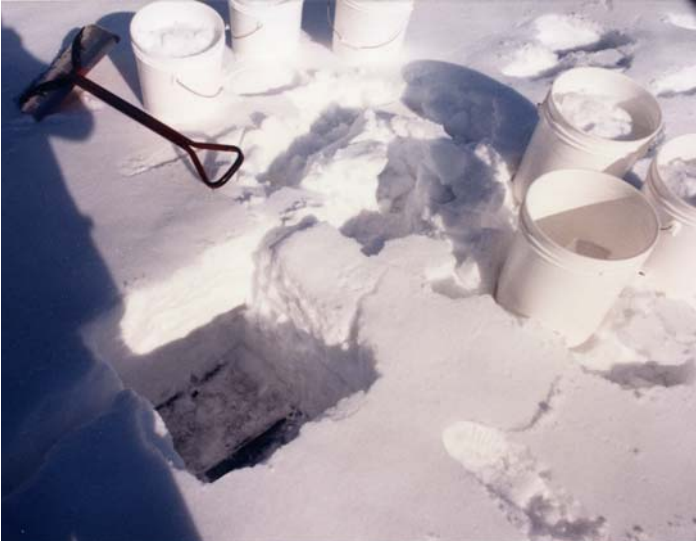
Zallen Engineering performed a field investigation of the collapse the day after the collapse. We made test holes into the snow to determine the density of the snow - see Figure 5, and we measured the depth of the snow at various representative points over the whole roof area. In general, the dismantling was done in such a manner that the condition and details of the framing and roof panels could be observed; however some of the details such as the connection of the roof panels across the ridge, were left uncertain. We saved representative framing and roof deck for further examination and measurement.

The average density of the snow was 15.1 pounds per cubic foot, and if the full 20 inches of snow were on the roof when it collapsed, the average resulting uniform snow load at the time of the collapse would have been 25.2 psf. The dead load of the framing and the roof deck was 5 psf. The Massachusetts State Building Code requires a snow load of 35 psf, and this loading was noted on the metal building drawings. The nomi-

Figure 5. Test hole in the snow on the roof, to determine the density of the snow.
