Collapse of Flying Formwork During Concrete Placement

Principal Rubin M. Zallen, P.E.
investigated this collapse.

Forensic Engineering in Construction® is published by Zallen Engineering, 1101 Worcester Road, Framingham, MA 01701. Comments are welcome. Please direct comments to Rubin M. Zallen, P.E., by telephone at 508-875-1360 or by e-mail at rmzallen@zallenengineering.com.

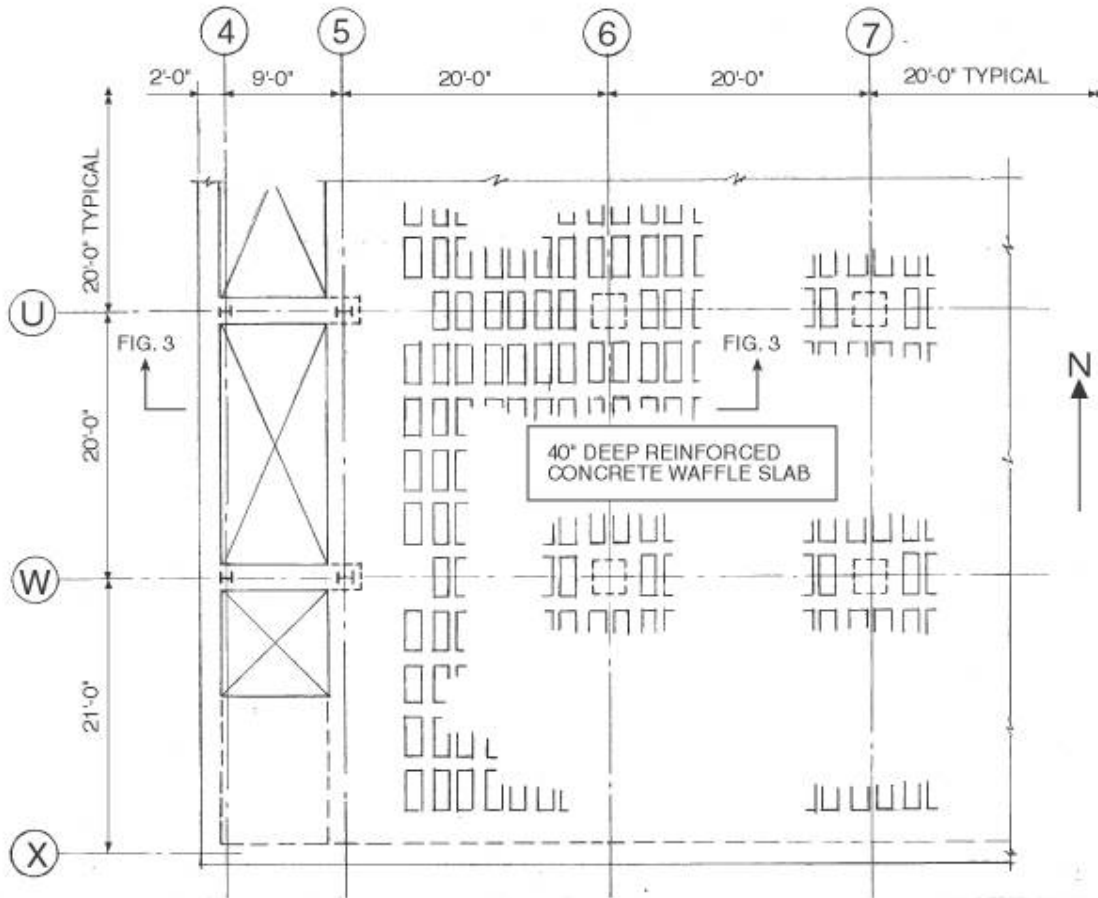
Figure 2

Part plan showing the southwest corner of the waffle floor slab. Adjacent floor construction is not shown.

The concrete pour started at the southwest corner and proceeded north to fill the first bay, between Lines 5 and 6. See Figure 2. The collapse occurred when the concrete in the first bay extended to Line 6 to the east, and approximately 70 feet to the north. Figure 9 (page 5) is a view of the collapse.

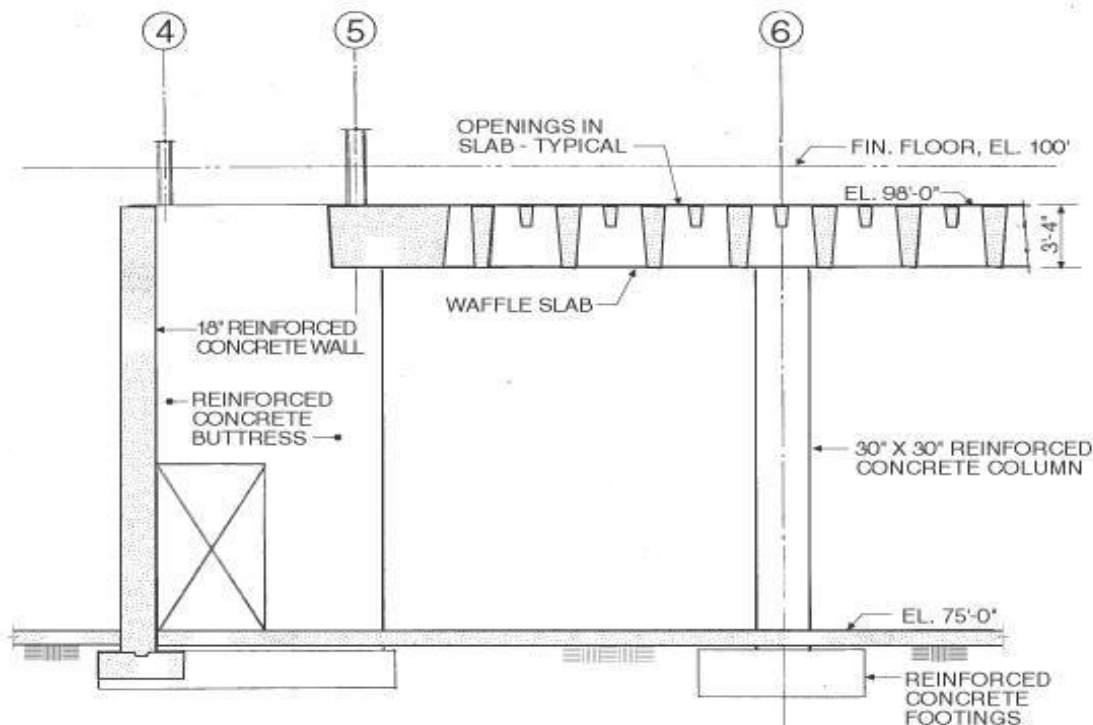
Figure 3

Section through waffle floor slab. Reinforcing steel and adjacent floor construction are not shown.

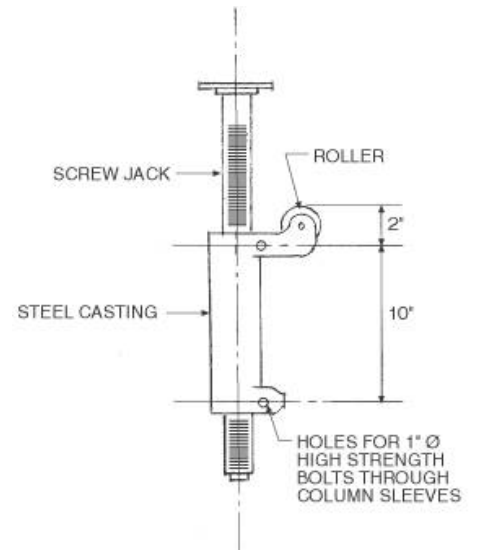
Figure 5. Side view of support fixture.

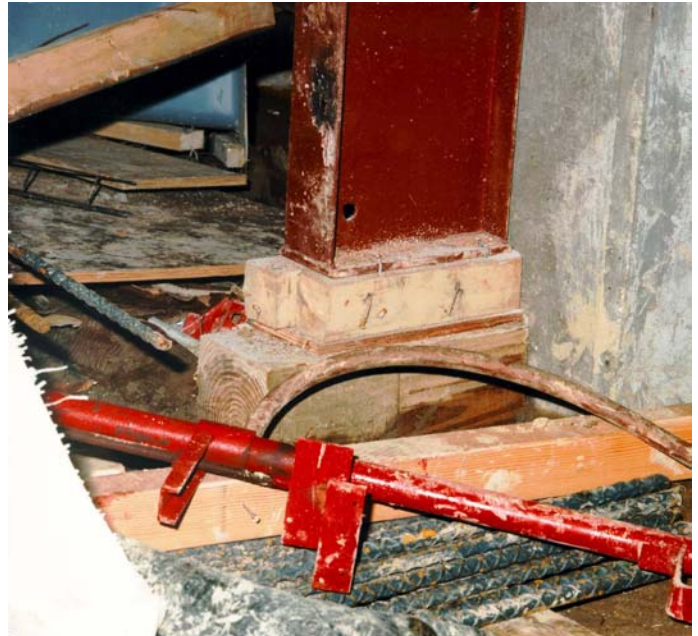
the top of the ground floor slab on grade. (The slab would be installed at a later time). The wood blocking supporting the column base plate was added in the field by the concrete subcontractor. See Figure 7.

Figure 7. Wood blocking supporting base plate of temporary steel column on Line 5; believed to be at the most northerly end of the formwork that collapsed. (The column shown did not collapse).

When the load from the concrete was imposed onto the steel columns adjoining the buttresses, the columns pushed down on and compressed the wood blocks, and at the same time loaded the expansion anchors in shear. A basic structural principle is that when load is shared between various elements, it will be transferred to the elements in proportion to their respective stiffnesses; the stiffer the element, the greater the percentage of load it will support. Relative to the steel column itself and to the expansion anchors, the wood blocking in compression is flexible, thus a substantial portion of the column load was transferred to the expansion bolts. Since the reaction (the resisting force) of the expansion bolts on the column is eccentric to (i.e., not in line with) the load on the top of the column, the top pair of expansion anchors were subjected to tension in addition to the shear on these anchors.³

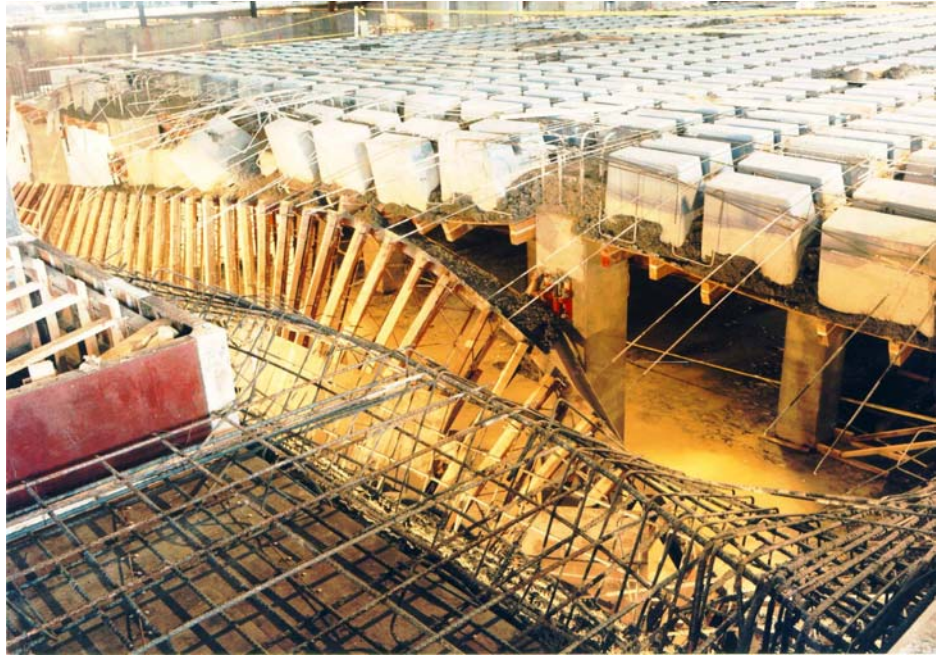
The failure was initiated at the temporary steel column at grid location W-5, which was one of the two most heavily loaded temporary columns, when the top pair of expansion bolts pulled out of the concrete in a concrete cone mode of failure, and the bottom pair of bolts sheared off. The vertical load was then completely transferred to the wood blocks; however, at the same time the column buckled laterally and collapsed, since, with the failure of the expansion anchors, it lost its intermediate lateral support. The failure of Column W-5 precipitating the collapse of the whole bay with most of the other temporary columns failing in a similar mode. The estimated load on the column when it failed was 90,000 lbs. The calculated ultimate capacity of the column with one flange braced laterally by the expansion anchors is 118,000 lbs. However, the calculated ultimate capacity without that flange being braced is only 40,000 lbs.

Figure 9. View of collapse, looking eastward.

The form designer, the concrete subcontractor, and the general contractor all made errors: 1) the form designer did not specify how the steel columns were to be supported at their base, 2) the form designer did not detail the columns to prevent vertical load transfer to the expansion anchors, 3) the concrete subcontractor did not request and obtain a support detail for the steel columns, and 4) the general contractor did not insist that the concrete subcontractor request and obtain said support detail.

The form designer used a slender steel shape for the column which is intended for use as a beam, which resulted in the requirement for intermediate lateral support to prevent buckling of the column perpendicular to the web. Had the designer provided a column that did not need intermediate lateral support, a shape that is normally used for columns, the wood blocks may have crushed, but the column would not have buckled.⁴ There would have been a downward displacement of the form table with the concrete along Line 5, but the form probably would not have collapsed.
