DEFICIENCIES IN BRACING OF LIFT SLAB BUILDINGS

Forensic Engineering in Construction® is published by Zallen Engineering, 1101 Worcester Road, Framingham, MA 01701. Comments are welcome. Please direct comments to Rubin M. Zallen, P.E., by telephone at 508-875-1360 or by e-mail at rmzallen@zallenengineering.com.

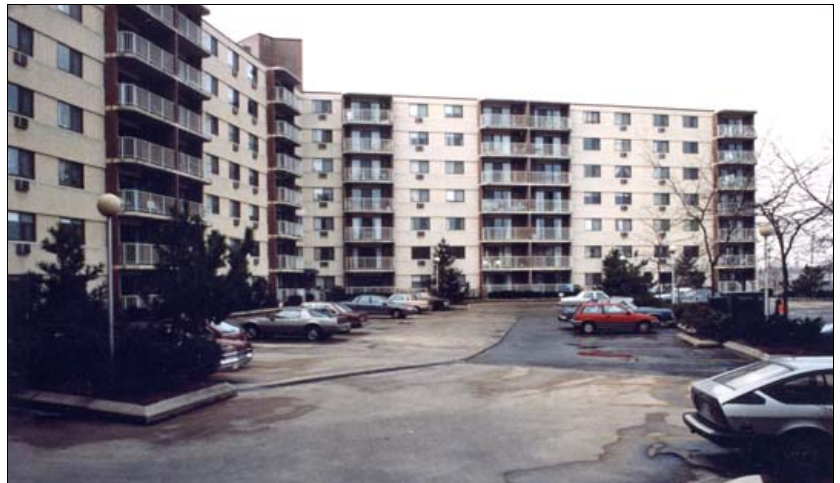
A second example of improper bracing was the lateral load resisting system for a large condominium in suburban Boston. Zallen Engineering was retained to give a second opinion on the lateral load resisting system of the condominium buildings. The complex consists of 3 buildings separated from each other by expansion joints. There are seven stories of residential condominium units and a basement story garage. Figure 8 shows a general view of the buildings. Figure 9 shows a schematic floor plan. Figure 10 is a schematic cross-section through the buildings.

Figure 8 Residential condominium complex in suburban Boston.

The lateral load resisting system was significantly overloaded when subjected to the code specified wind load. The kinked diagonals in the braced frames were essentially ineffective in resisting force and the moment connections between the slabs and the columns had little moment resistance and were generally inadequate. Further, some of the flat bar diagonals of the braced frames were severely overloaded, with ratios of load to safe load as high as 1.7, the nominal safety factor for steel.
