## Collapse of a Trunk Storm Sewer in Boston

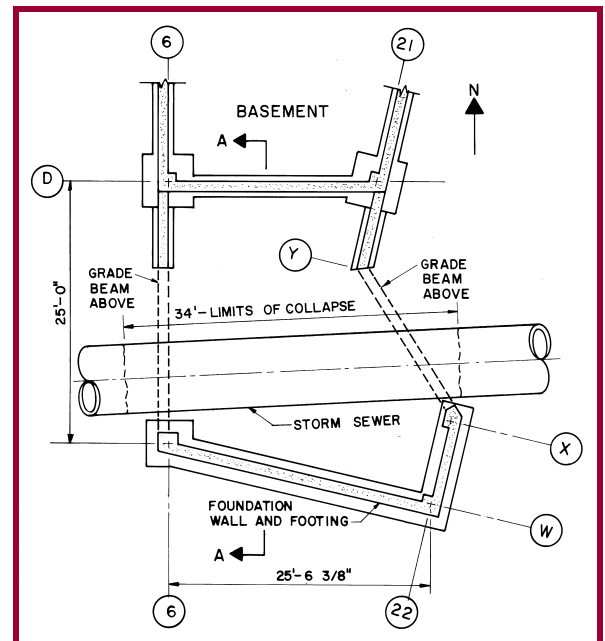
struct a small portion of the building over the storm sewer. Figure 2 shows a plan of the foundation design in the vicinity of the sewer. Figure 5 (*on page 3*) shows a schematic section through the building foundation and the sewer, as designed. The section is taken as indicated on Figure 2.

**Figure 2.** Foundation plan in the vicinity of the storm sewer, as designed.

The developer was also the general contractor for the project. He first constructed the foundation for the portion of the building with a basement, which runs from Line D northward (see Figure 2), and then proceeded to build the portion of the foundation south of Line D.

The excavation subcontractor used a large hydraulic excavator on tracks which stays on the top of the bank, excavates down into the excavation, and moves backwards as it excavates (called a backhoe). For the excavation work south of Line D, the excavation subcontractor first excavated trenches for the short extension wall and the grade beam on Line 6 (see Figure 2),

The sewer collapsed just after the excavation subcontractor completed his work and parked his machine beyond the southeast corner of the excavation. Figure 2 shows the extent of the collapse, Figure 3 shows a portion of the collapsed sewer, and Figure 4 shows details of its clay tile masonry construction. The depth of the soil over the top of the sewer, just before the collapse, was approximately 3 feet where the grade beam trenches crossed over the sewer, and 8 feet between the grade beam trenches.
